Architect Field Report #20

Project: Rehabilitation of FQ Sanchez Project No.: 144067.02 Date: 02/06/2026

Reported by: Joseph Pangelinan

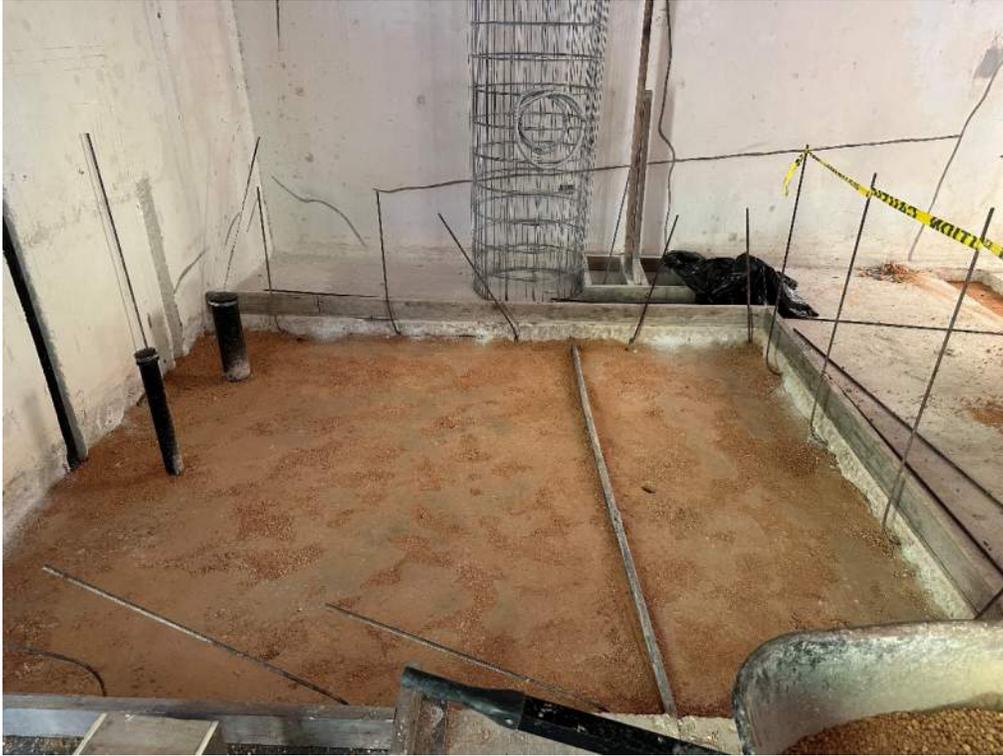
B1.1 Plumbing at restroom near Museum Display Area #2 – Base course compaction

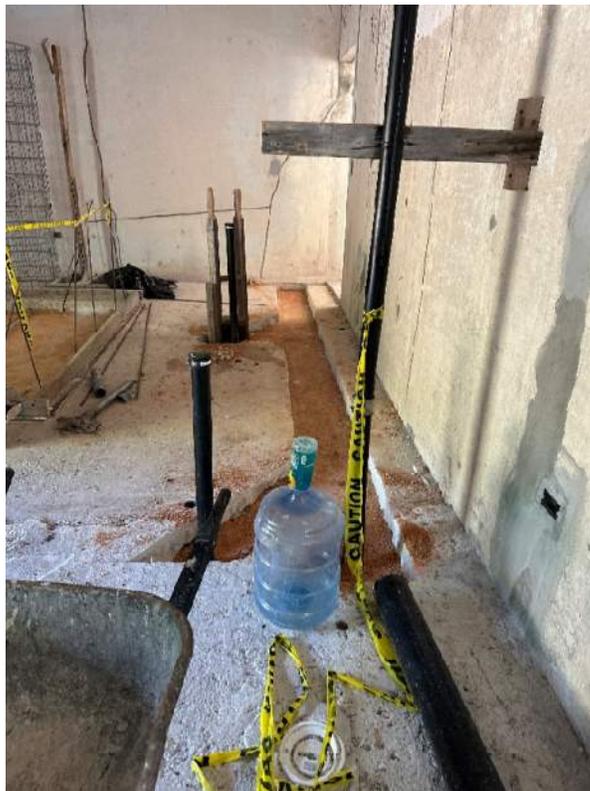
B1.2 Plumbing at restroom near Museum Display Area #2 – Base course compaction

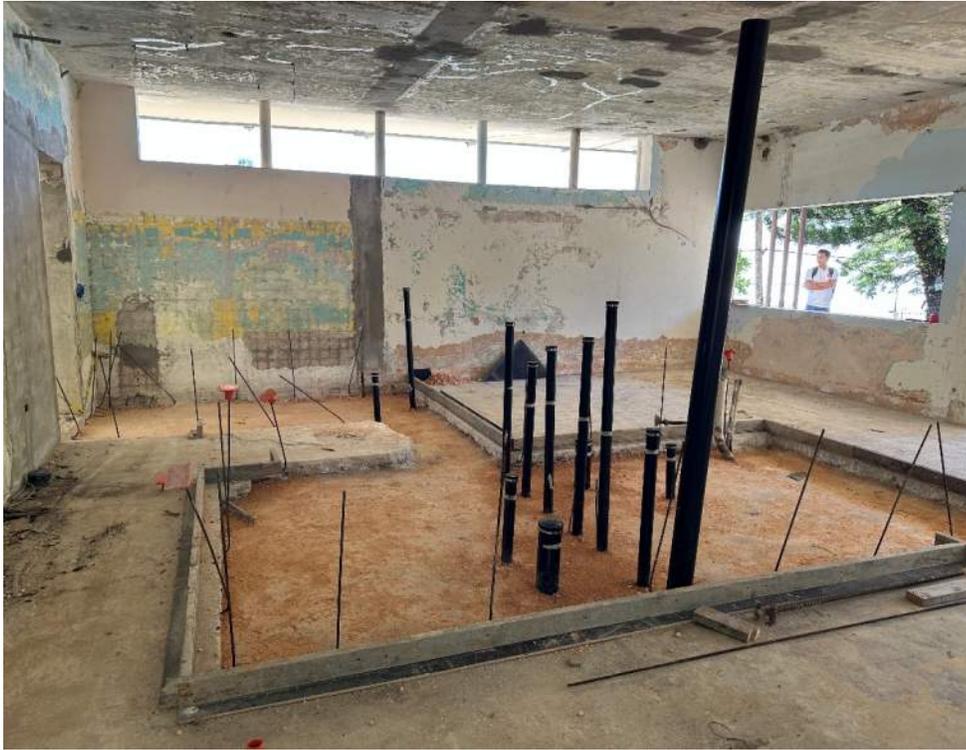
B2.1 Plumbing at restroom at Office/Reception Area - Base course compaction

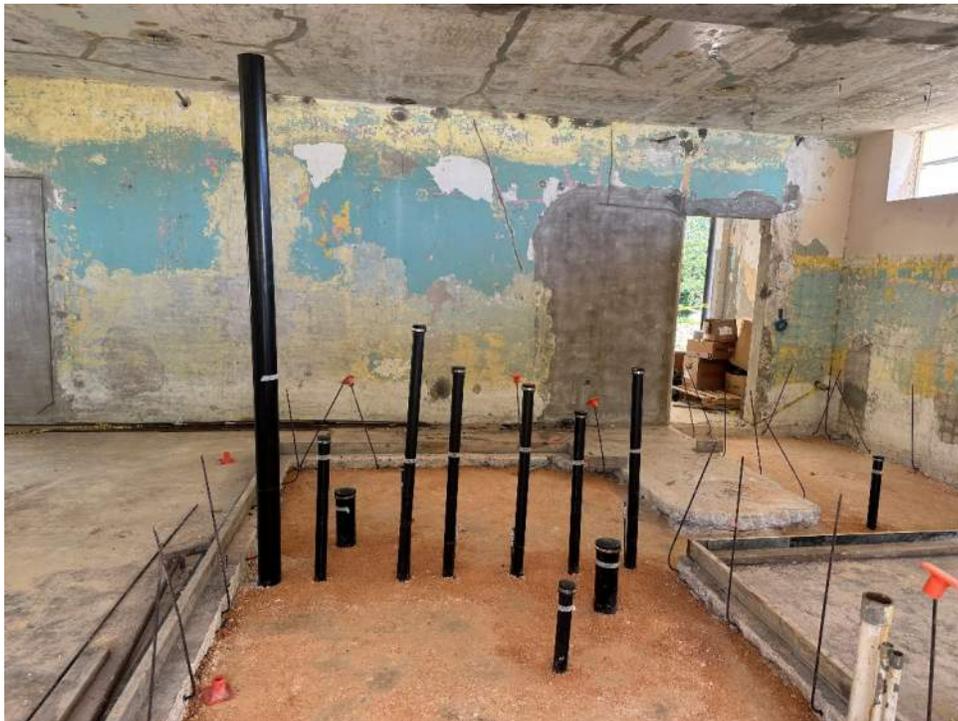
B2.2 Plumbing at restroom at Office/Reception Area - Base course compaction

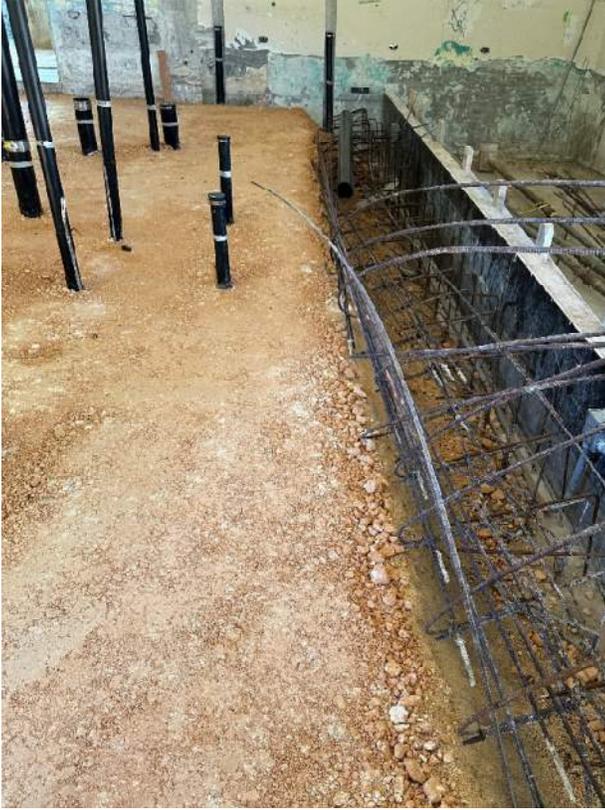
B3.1 Plumbing work at Men's/Women's area – Upper Level -Edge requires additional compaction with fines

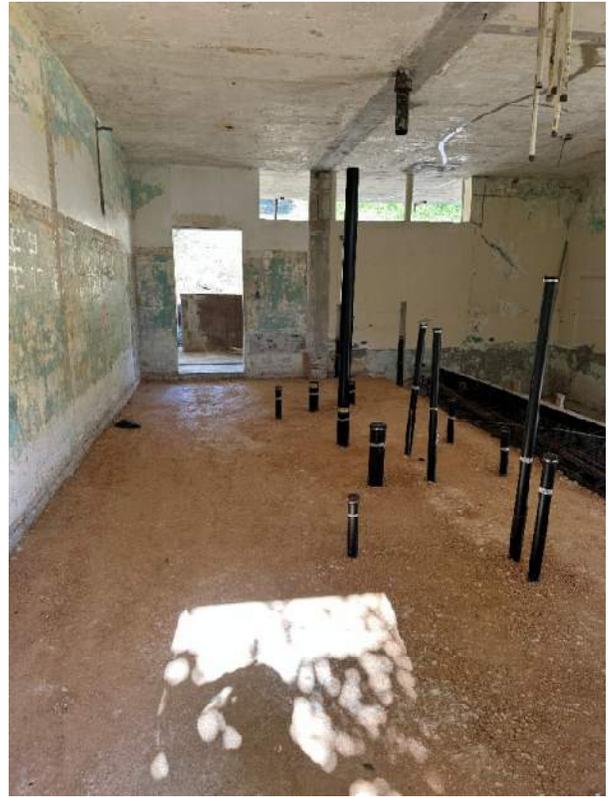
B3.2 Plumbing work at Men's/Women's area – Upper Level

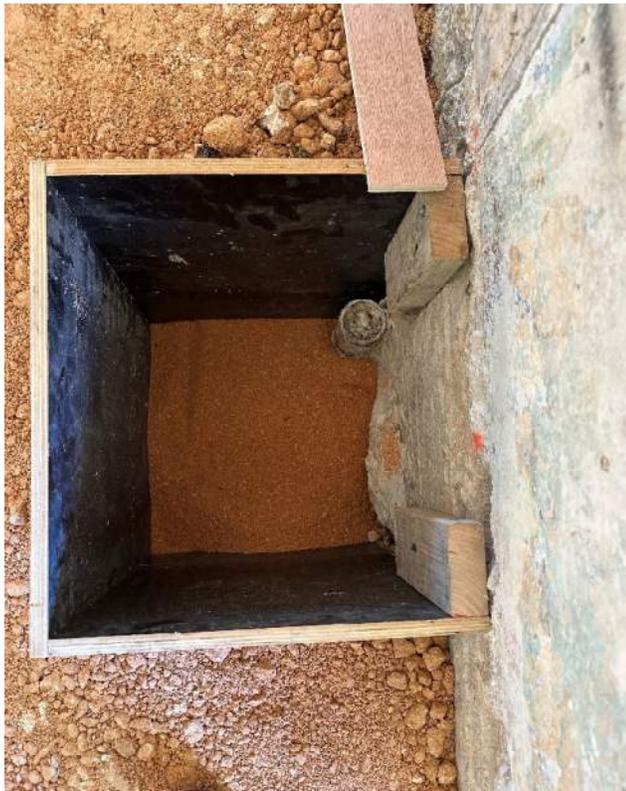
B3.3 Plumbing work at Men's/Women's area – Valve box

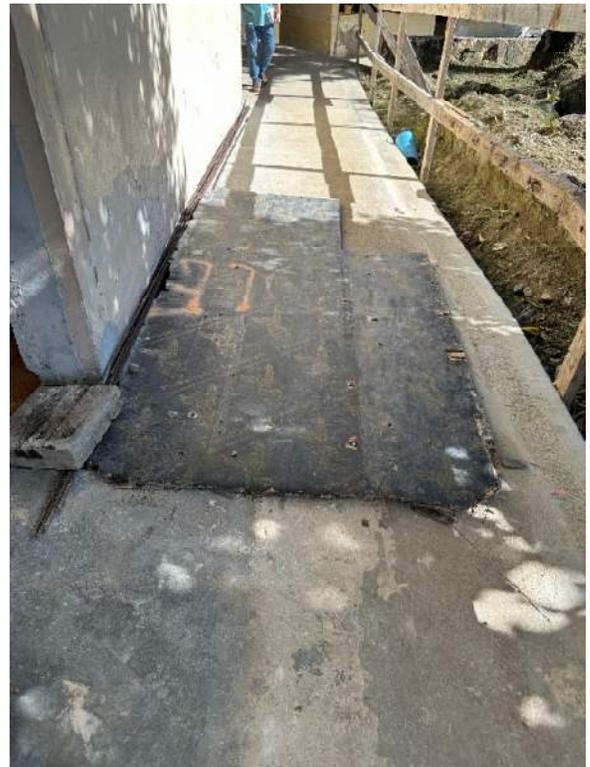
B3.4 Plumbing work at Men's/Women's area @ Ramp

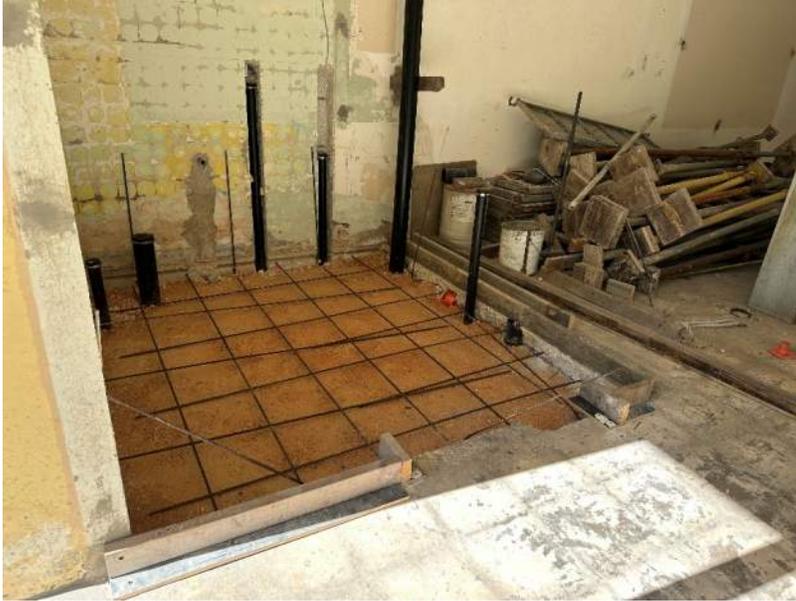
B4.1 Plumbing work for Toilet - Classroom #1

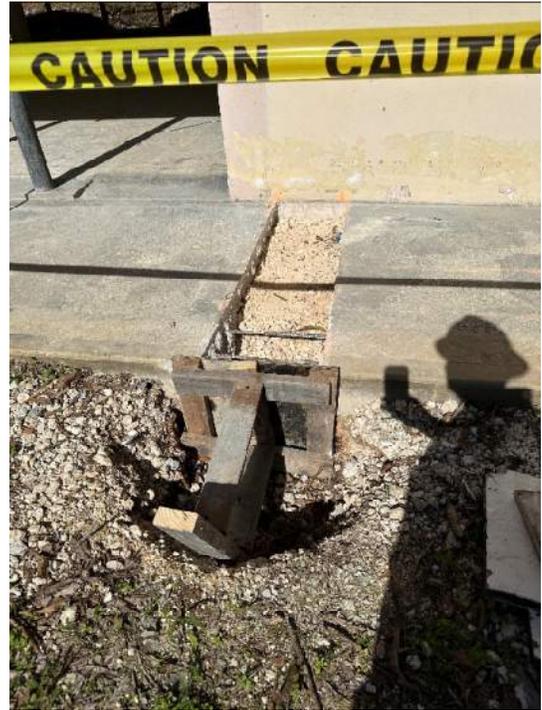
B4.2 Plumbing work for Toilet - Classroom #1 -Exterior Wall

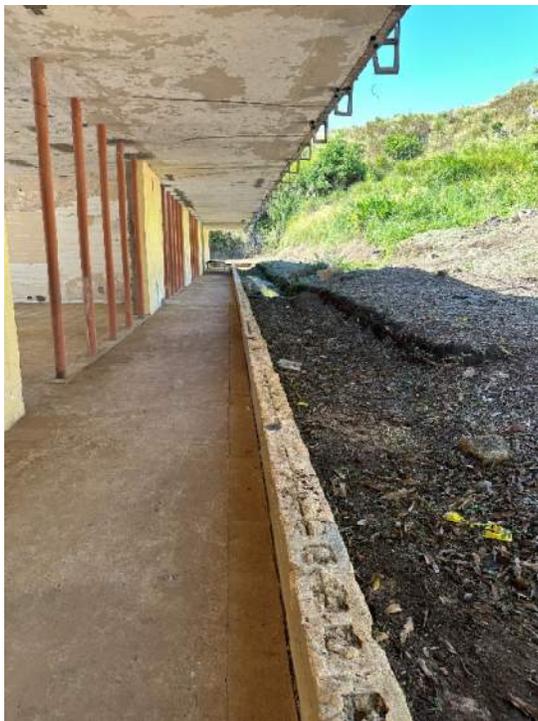
B5.1 Site upkeep – Upper Level Backside

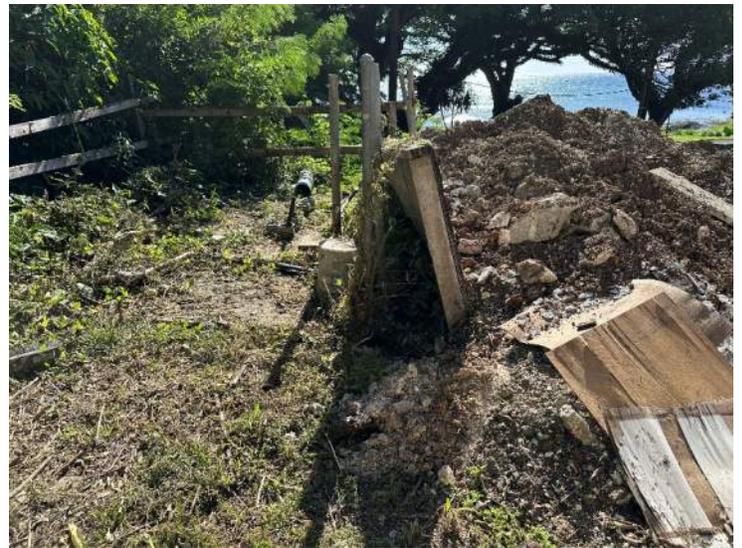
B5.2 Site upkeep – Near Transformer

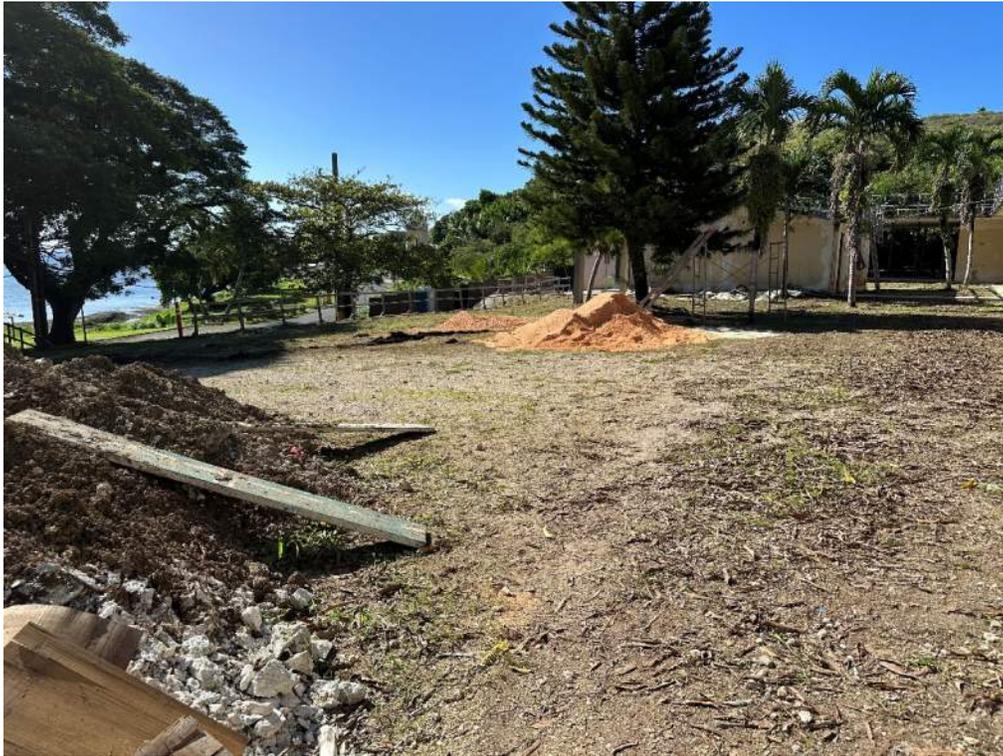
B5.3 Site upkeeping – Upper level Front side

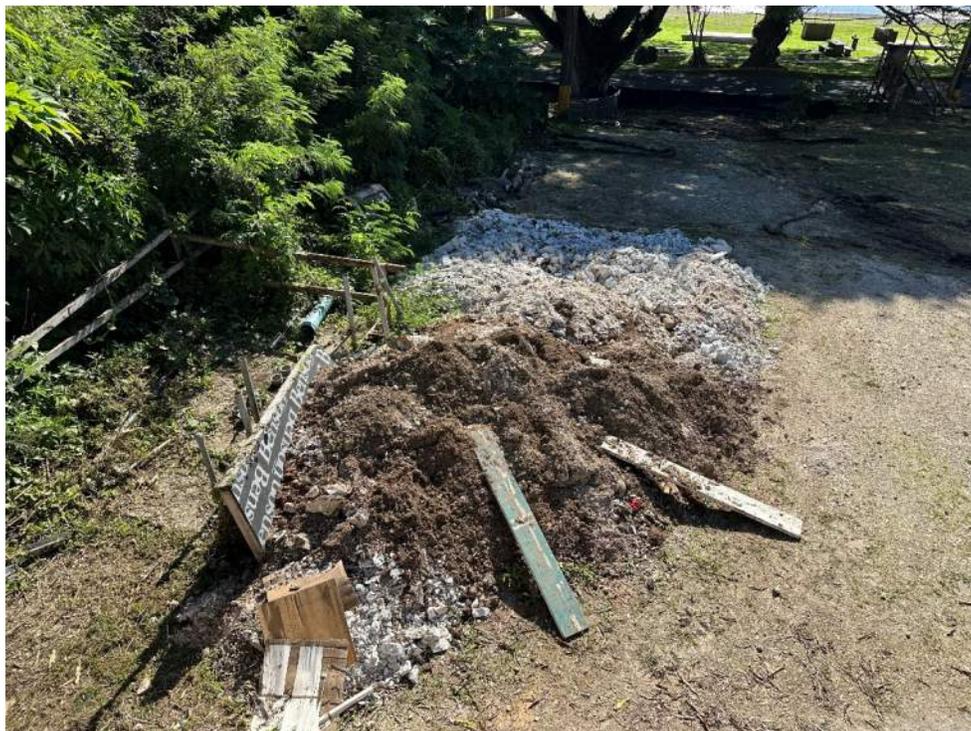
B5.4 Site upkeeping – Upper level Front side, Demo debris to be removed

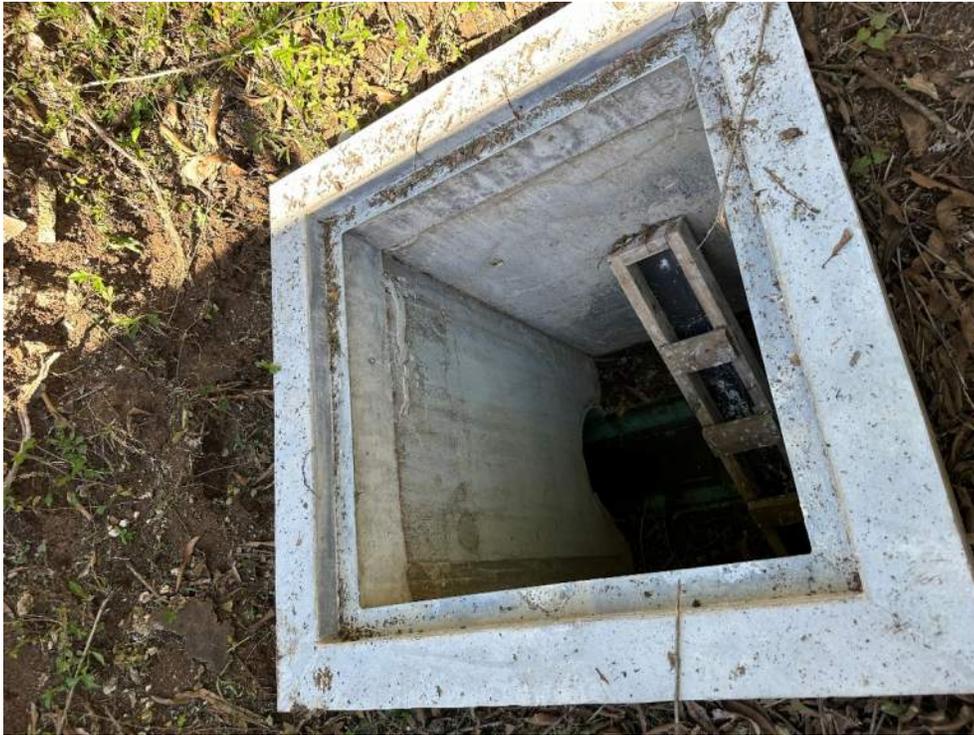
B5.5 Site upkeeping – Backside storm drain missing cover

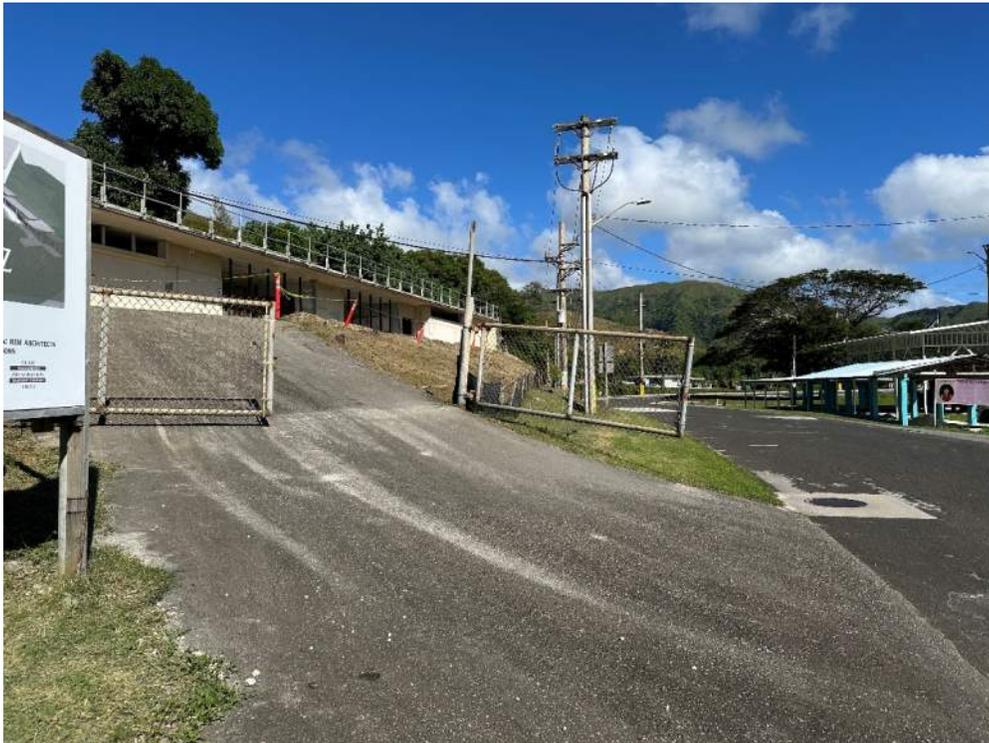
B5.6 Site upkeeping – Lower level view from road

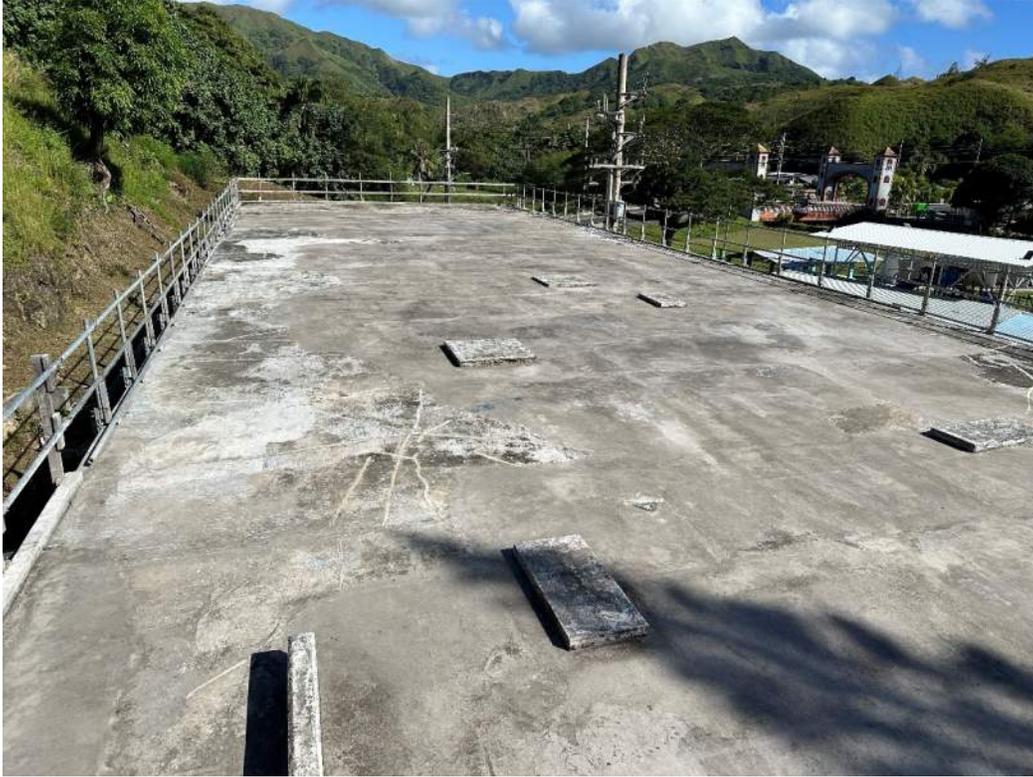
B6.1 Lower level roof – mildew visible

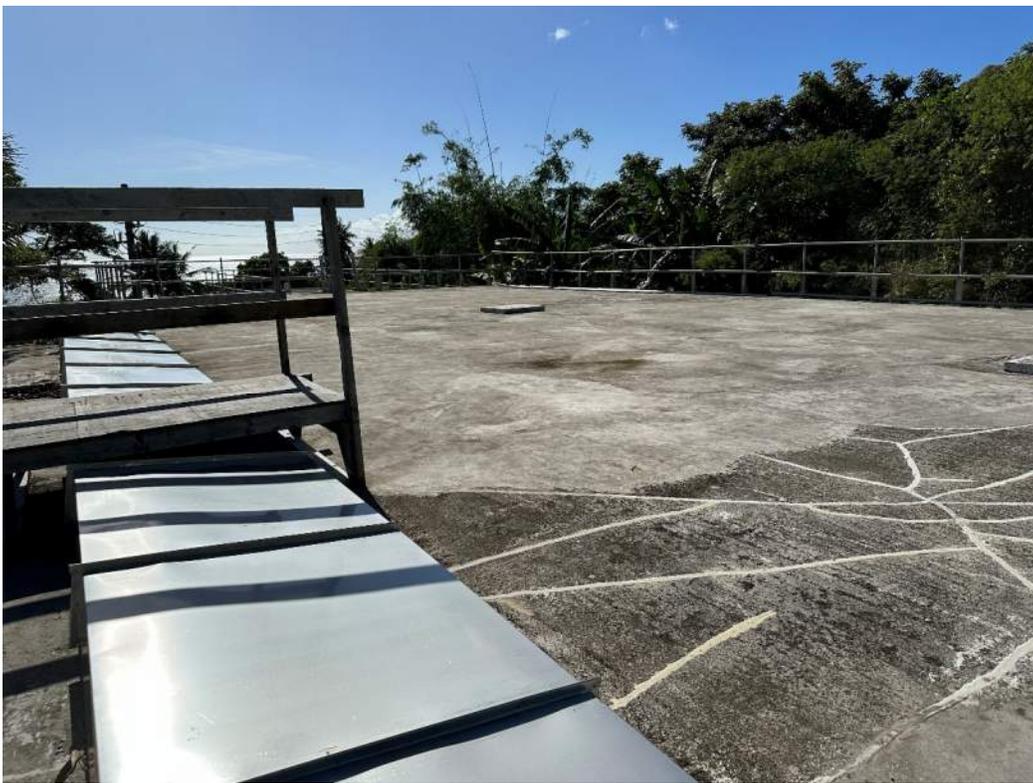
B6.2 Stainless steel flashing at roof level

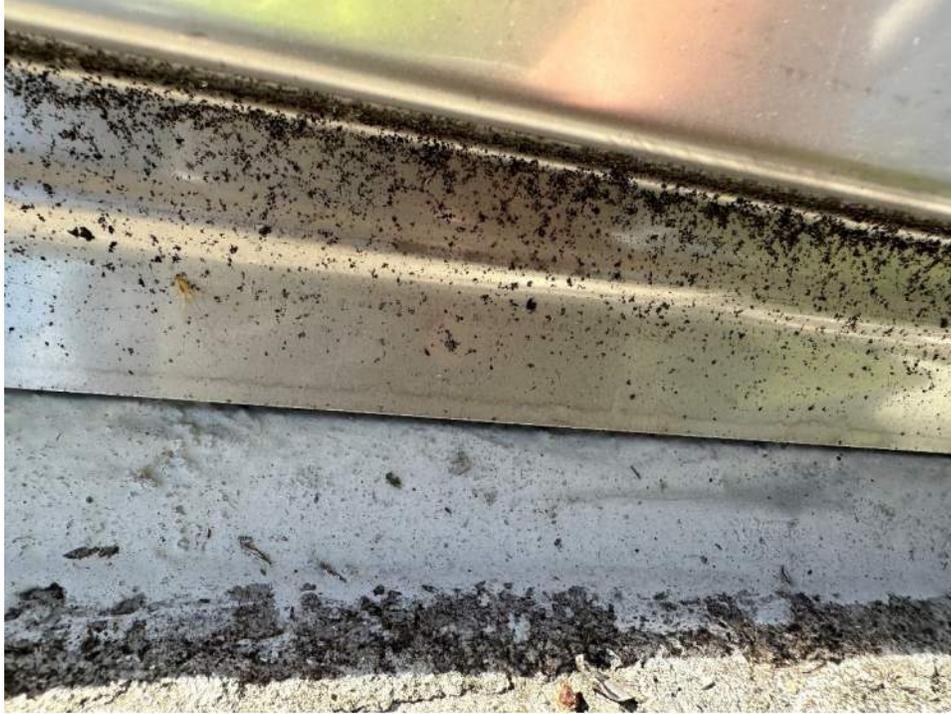
B6.3 Stainless steel flashing between Classroom #5 & #6 with paint coating (not silicone)

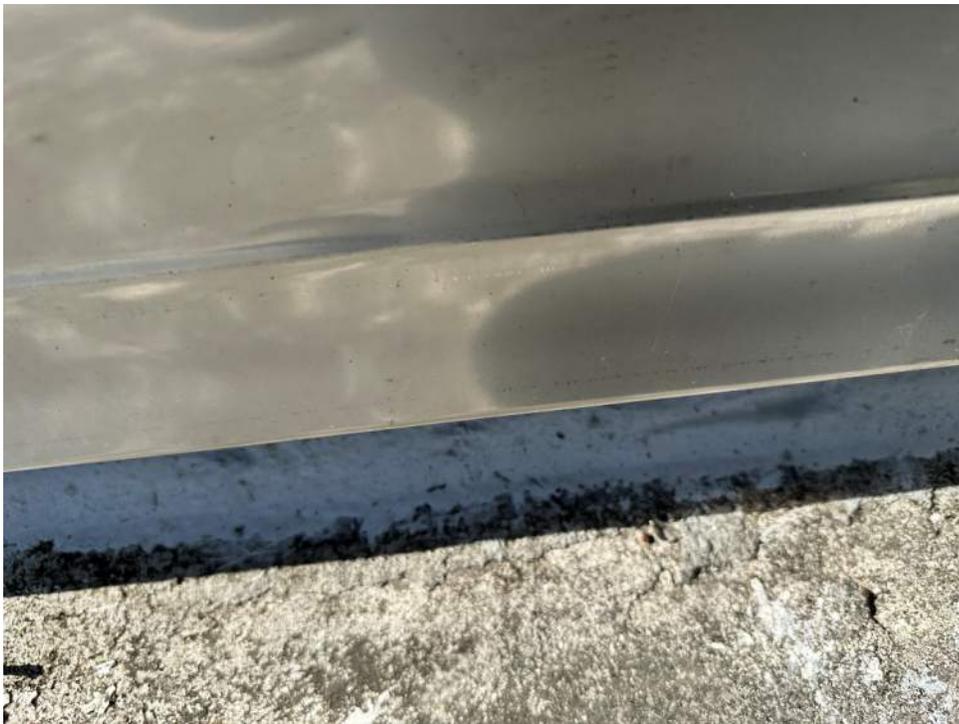
B6.4 Stainless steel flashing between Classroom #5 & #6 with drip edge

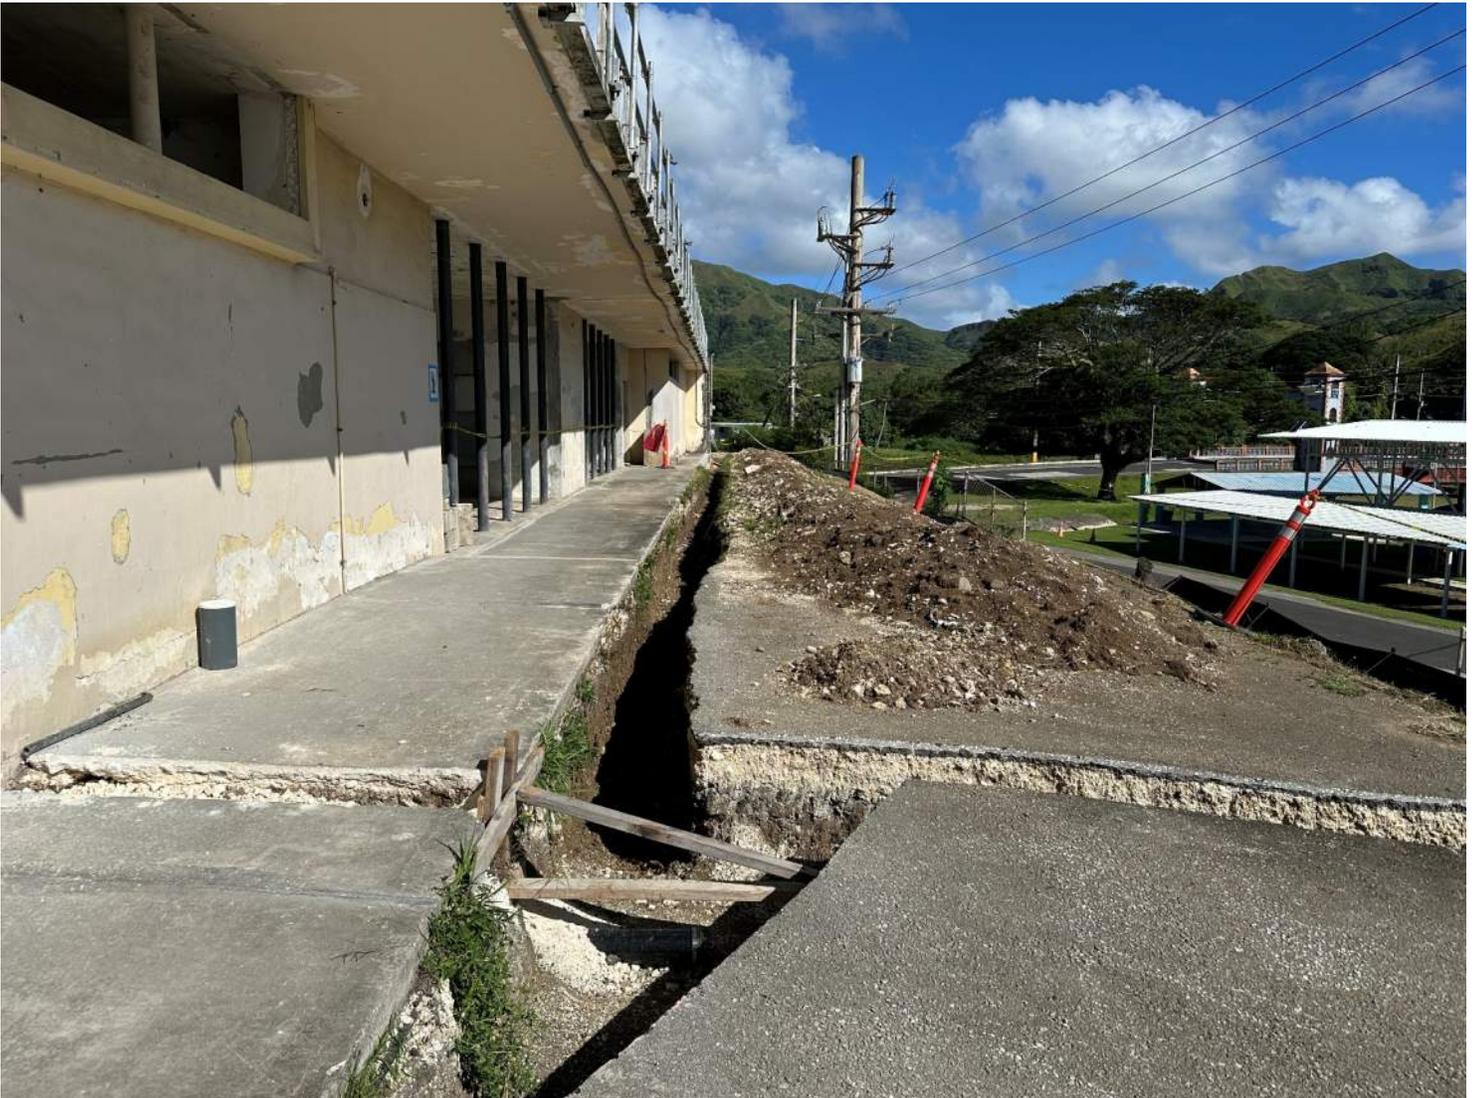
B7.1 Lower level trench not properly secured
