# Architect Field Report #18

Project: Rehabilitation of FQ Sanchez      Project No.: 144067.02      Date: 01/09/2026

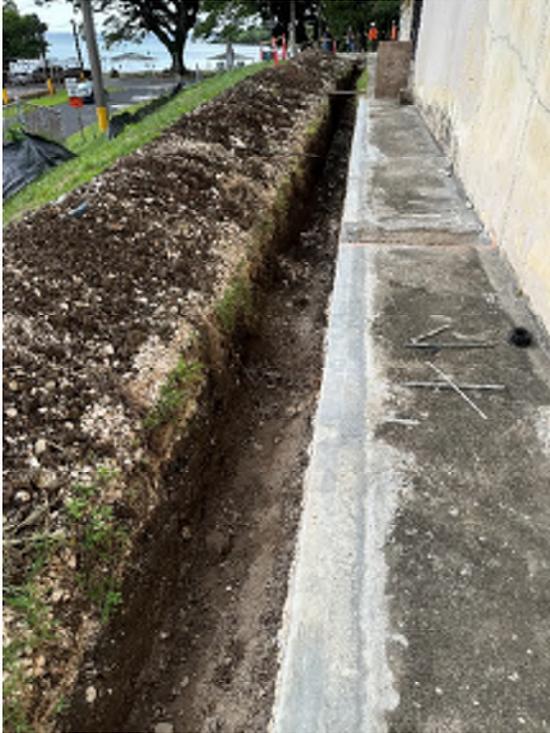
1. Trenching outside building w/o Archaeologist presence.
2. Existing broken sewer line outside building will require replacement.
3. Trenching of existing sewer pipes and water meter.
4. Trenching for plumbing in Main Building - Museum Display Area #2.
5. Trenching for plumbing in Main Building – Office Reception Area.
6. Trenching for plumbing in Main Building – Men's/Women's at upper level.
7. Trenching for plumbing in Classroom #1 – Toilet room.
8. Grass cutting around site is ongoing.
9. Existing transformer has been removed. Stub-outs need to be removed & secured.
10. Stainless steel flashing installed between Classroom #5 & #6.

B1.1 Trench work in front of Main Bldg-Museum

Contractor was advised by GPT/GHD to stop all digging until Archaeologist can supervise digging and confirm that no significant impact has been done to the site. Majority of trench work for sewer piping around restroom areas has been completed without supervision from an archaeologist. Work is currently on hold pending availability of Kleinfelder representative.

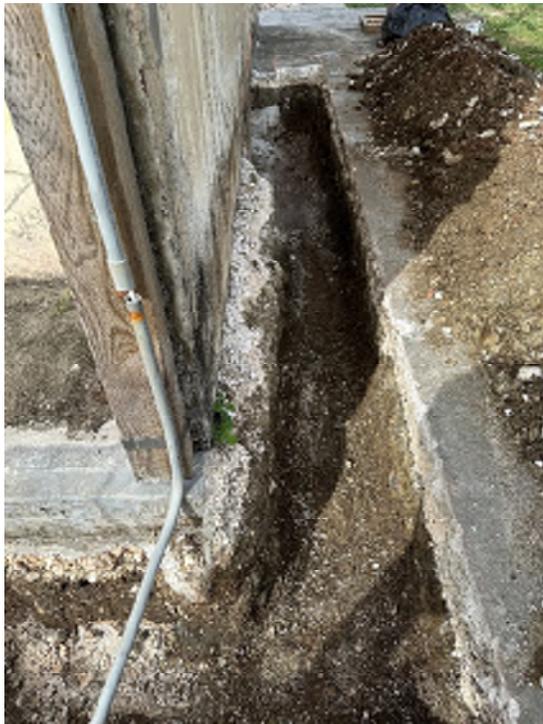
B1.2 Trench work at side of Main Bldg –  
Museum Display Area

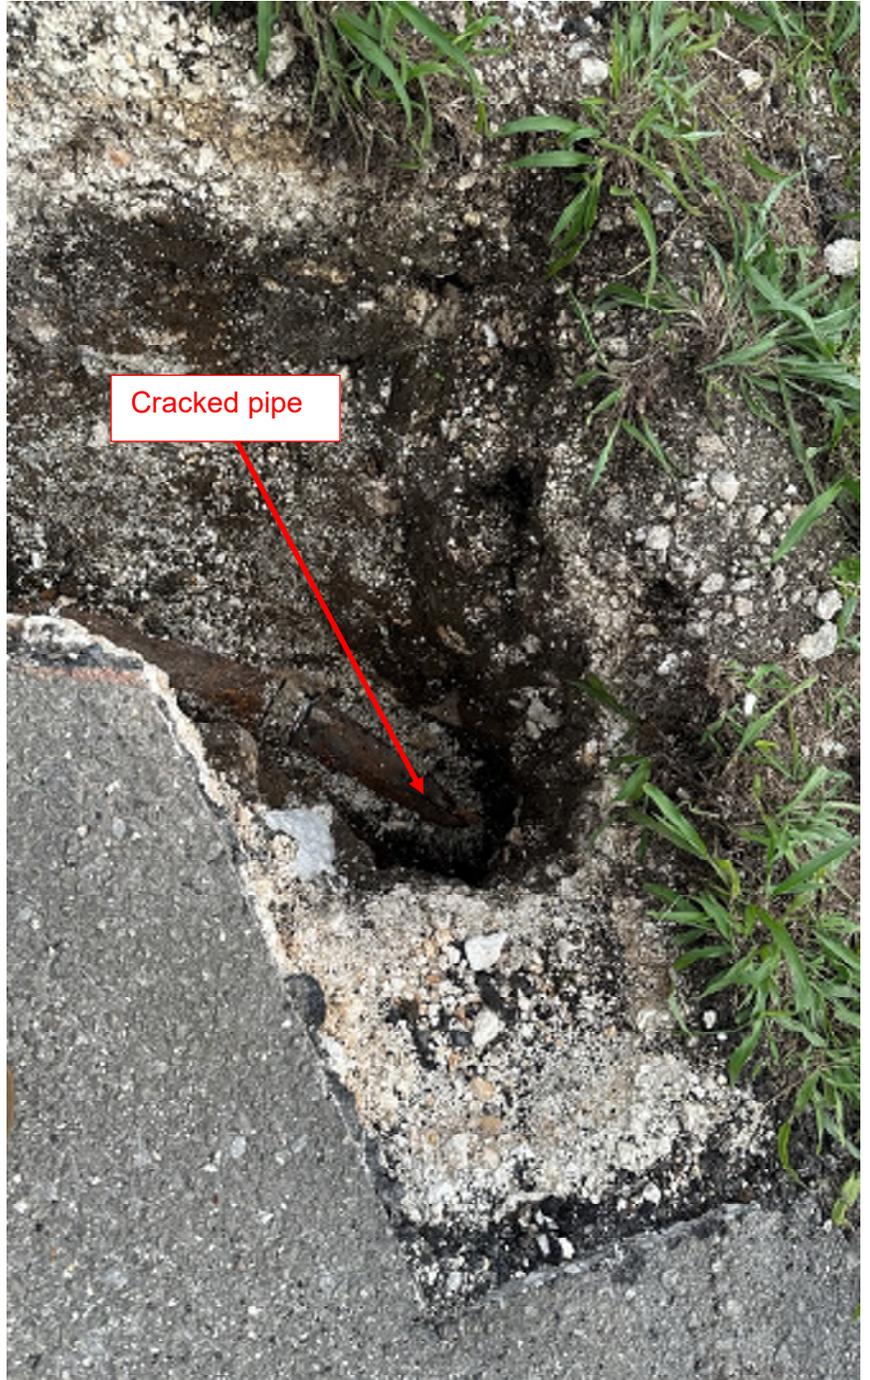
B2.1 Damaged/rusted sewer line pipe

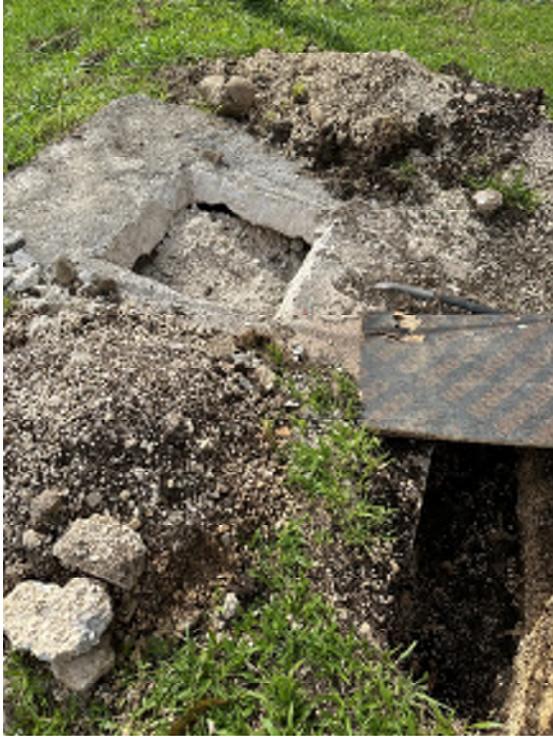
B3.1 Trench work near existing water meter

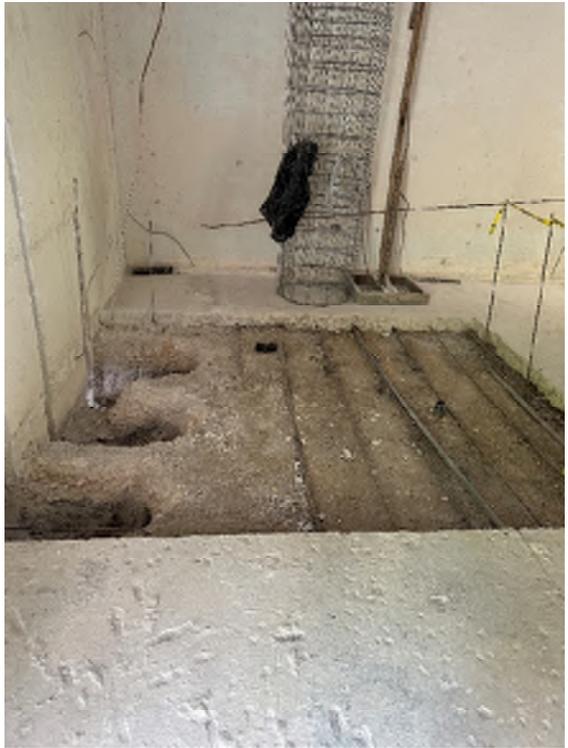
B4.1 Trench work for plumbing at restroom near Museum Display Area #2

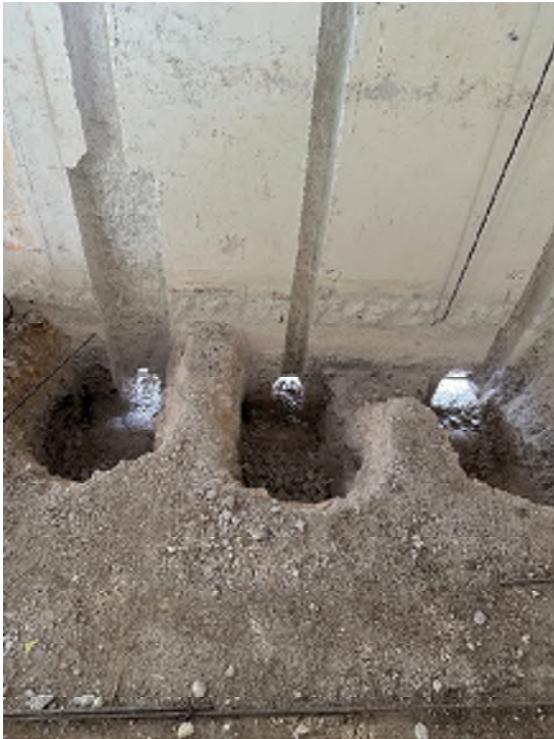
B4.2 Trench work for plumbing at restroom near Museum Display Area #2 – penetration thru exterior wall

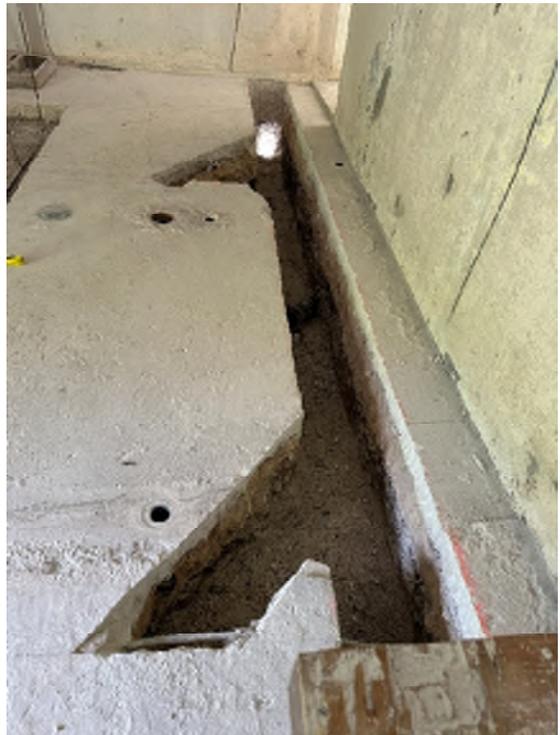
B4.3 Trench work for plumbing at restroom near Museum Display Area #2

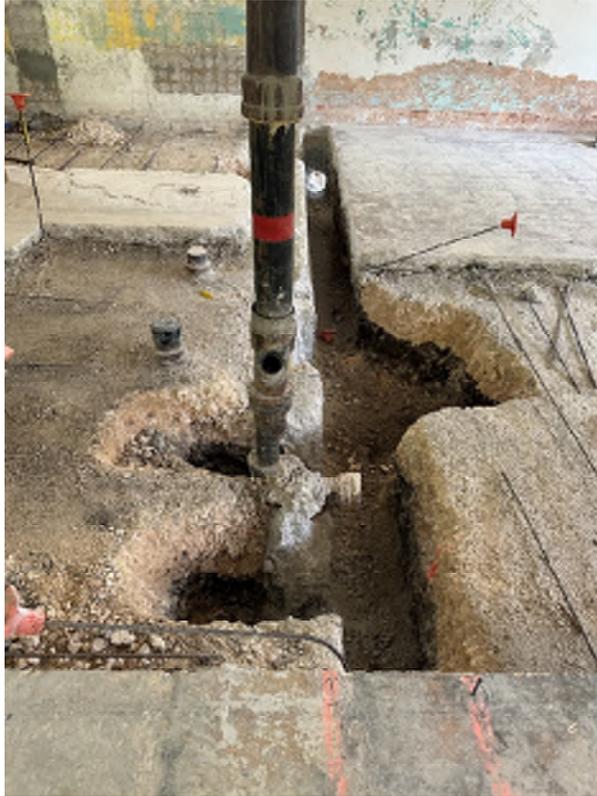
B5.1 Trench work for plumbing at restroom at Office/Reception Area

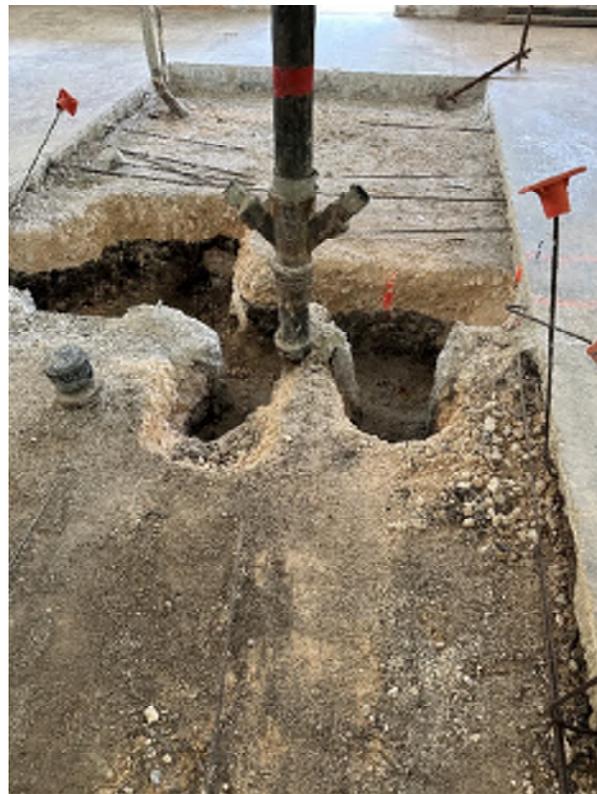
B5.2 Trench work for plumbing at restroom at Office/Reception Area

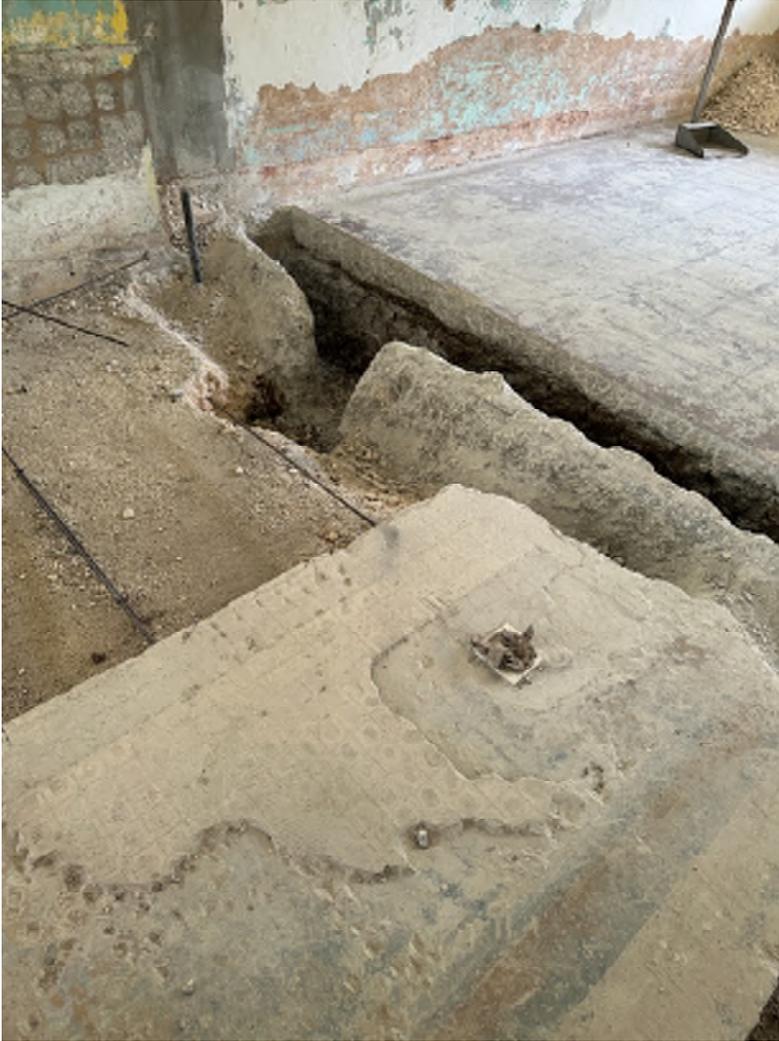
B5.3 Trench work for plumbing at restroom at Office/Reception Area

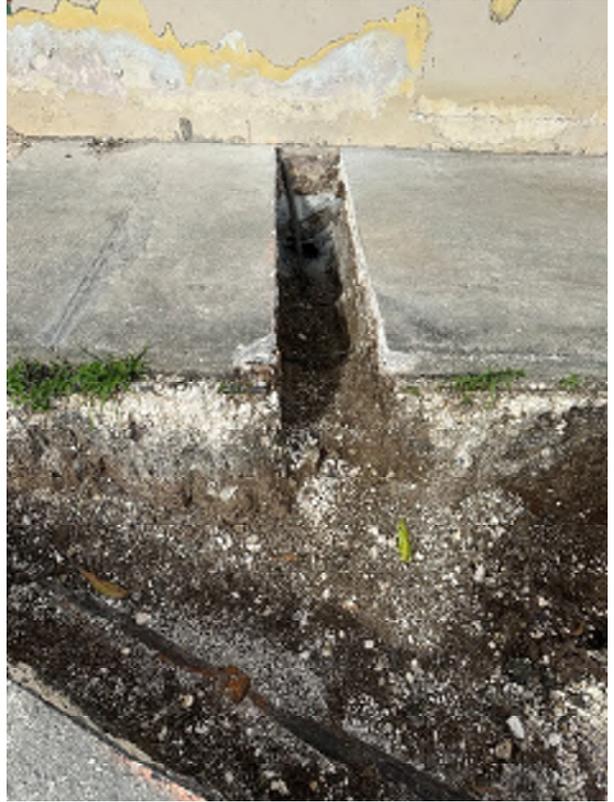
B5.4 Trench work for plumbing at restroom at Office/Reception Area - Exterior

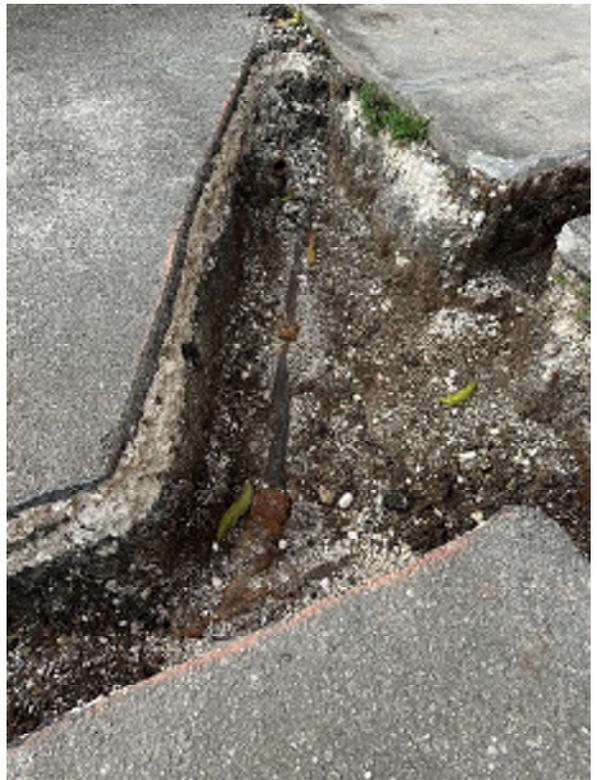
B5.5 Trench work for plumbing at restroom at Office/Reception Area - Exterior

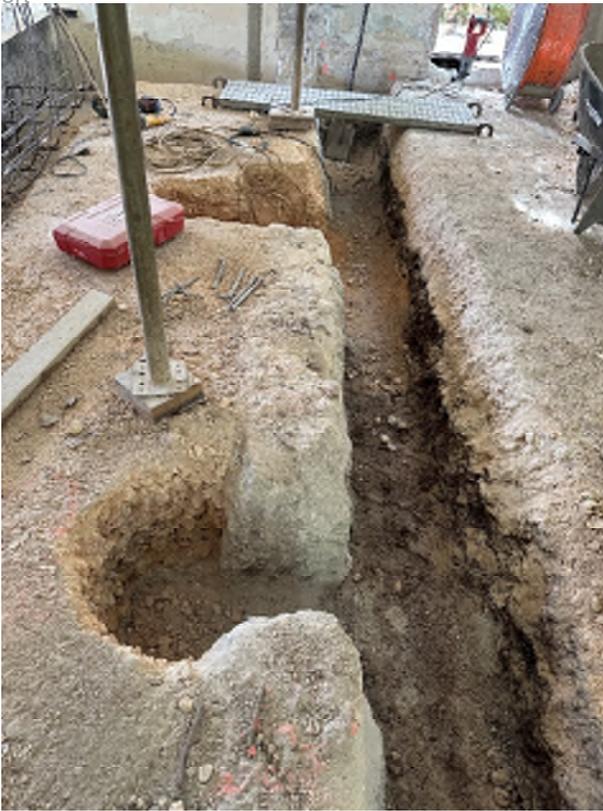
B6.1 Trenching work at Men's/Women's area – Upper Level

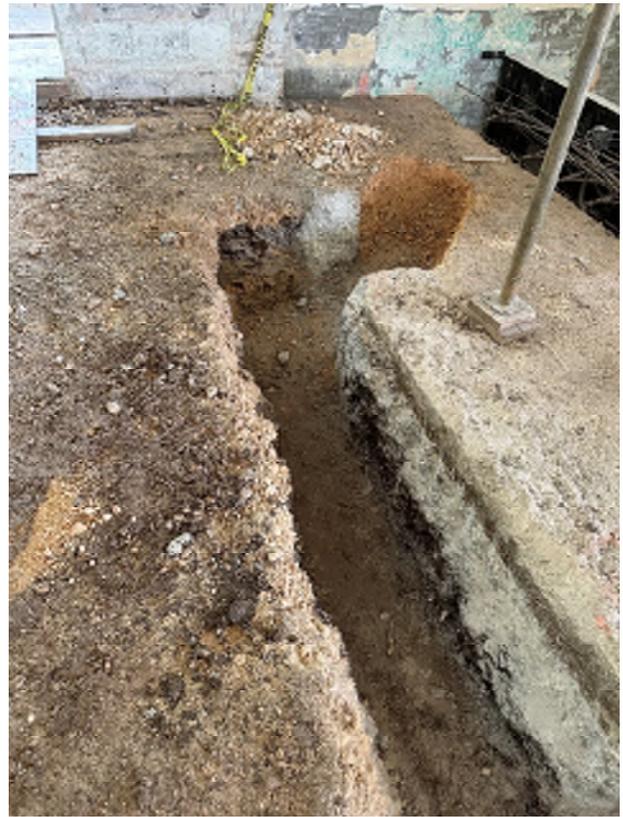
B6.2 Trenching work at Men's/Women's area – Upper Level

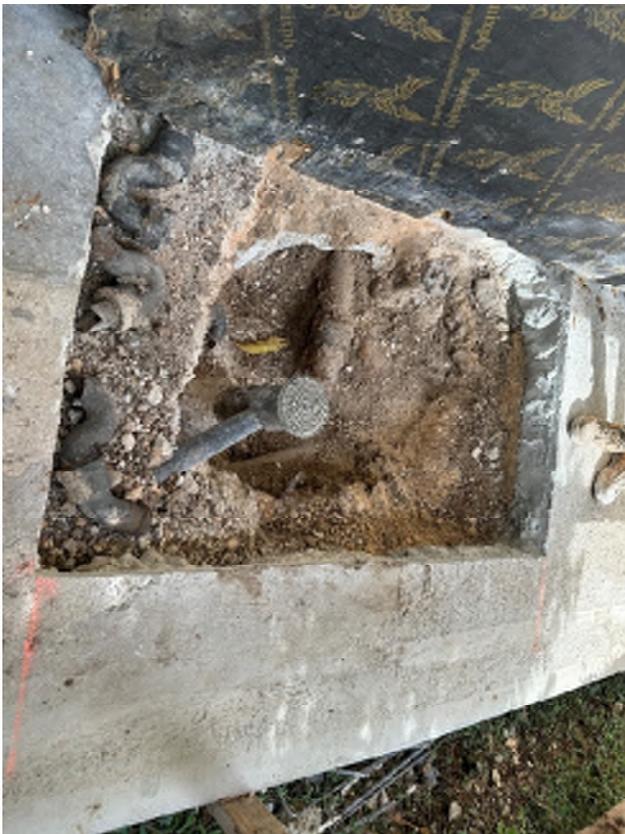
B6.4 Trenching work at Men's/Women's area – Ramp

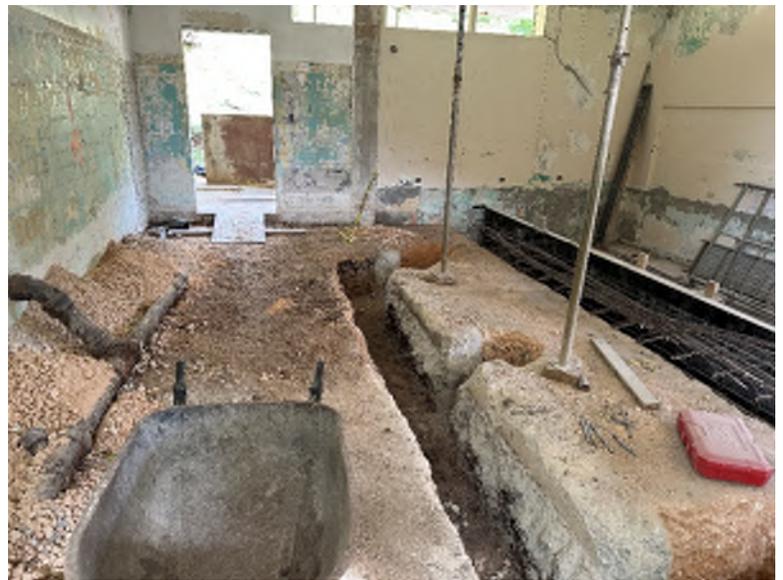
B6.3 Trenching work at Men's/Women's area – Upper Level

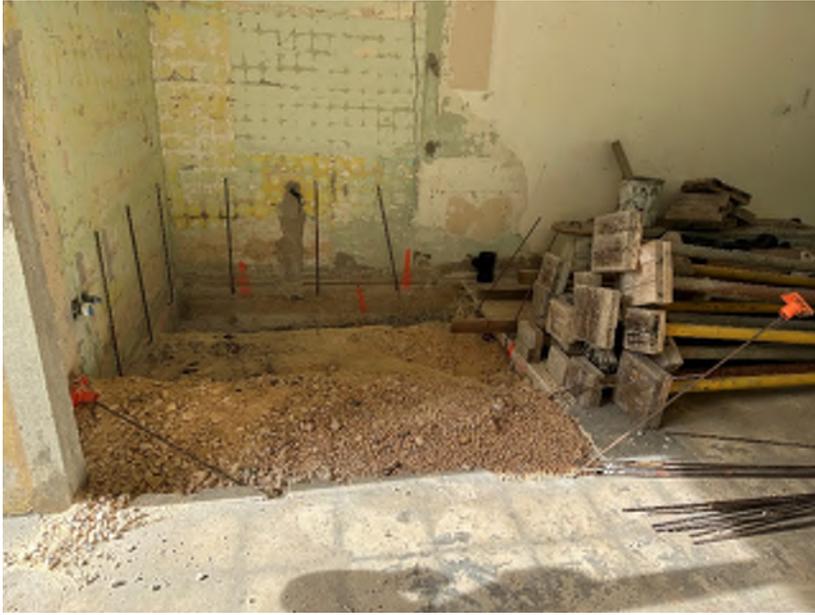
B7.1 Trench work for Toilet - Classroom #1

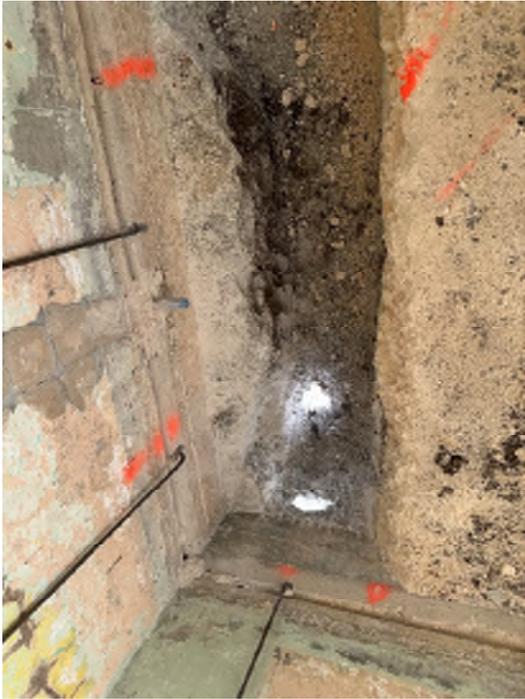
B7.2 Trench work for Toilet - Classroom #1 -Exterior Wall

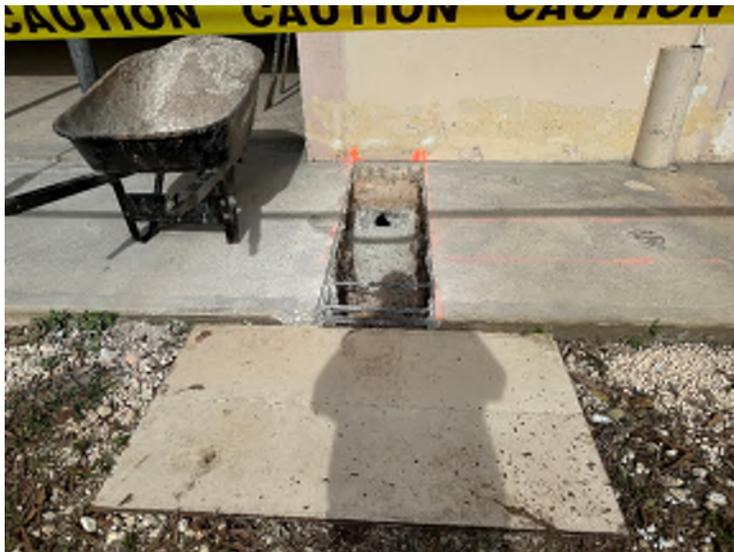
B7.3 Trench work for Toilet - Classroom #1 -Exterior Wall

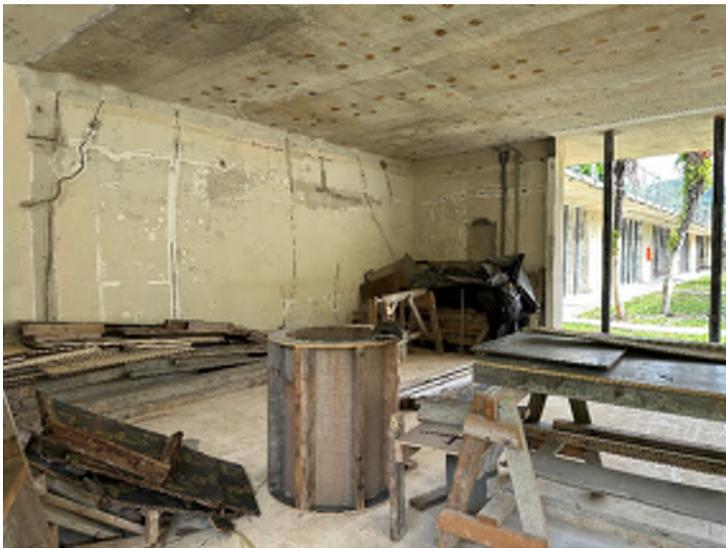
B8.1 Site upkeep – Material Storage

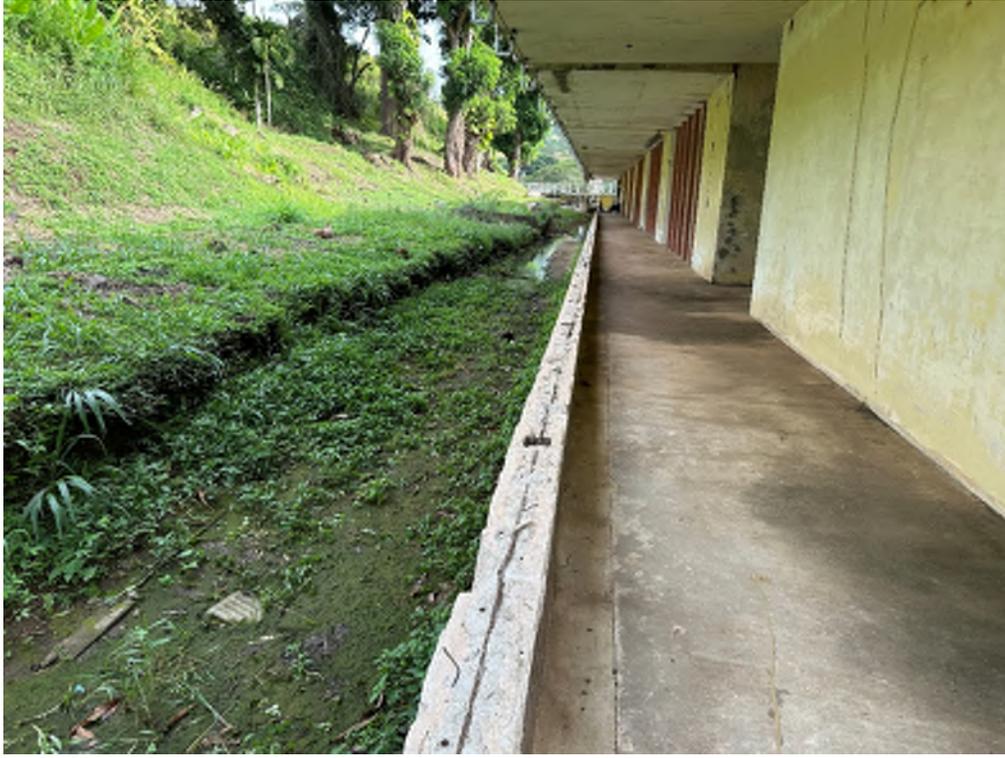
B8.2 Site upkeeping - Backside

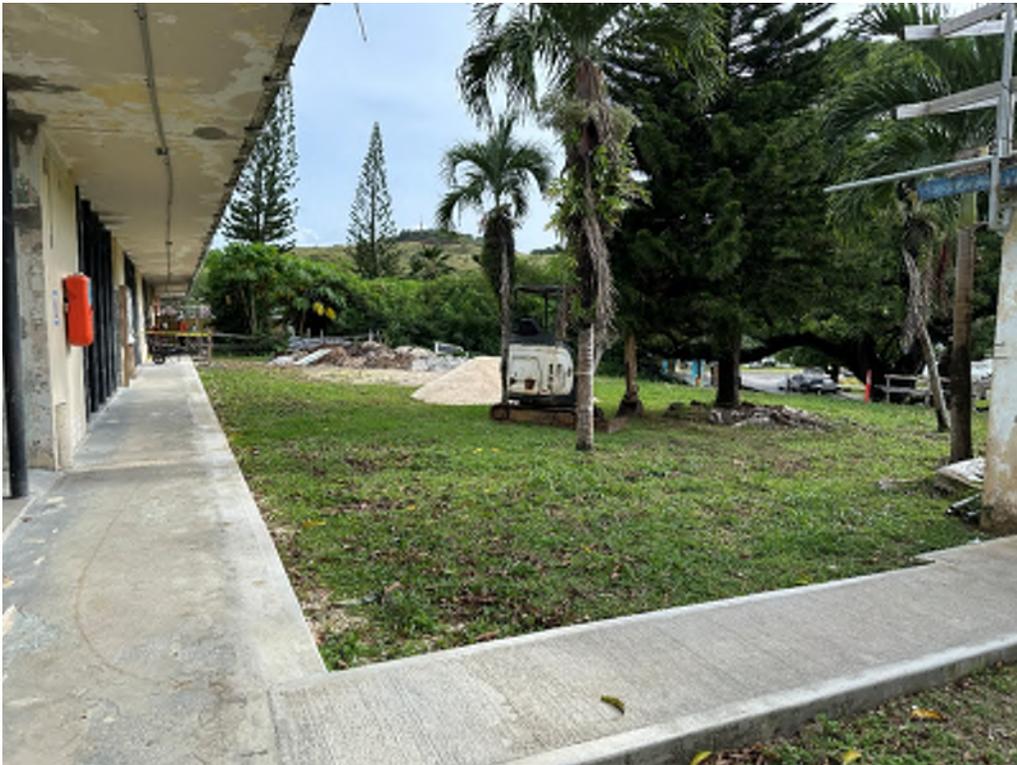
B8.3 Site upkeeping – Front side @ upper level

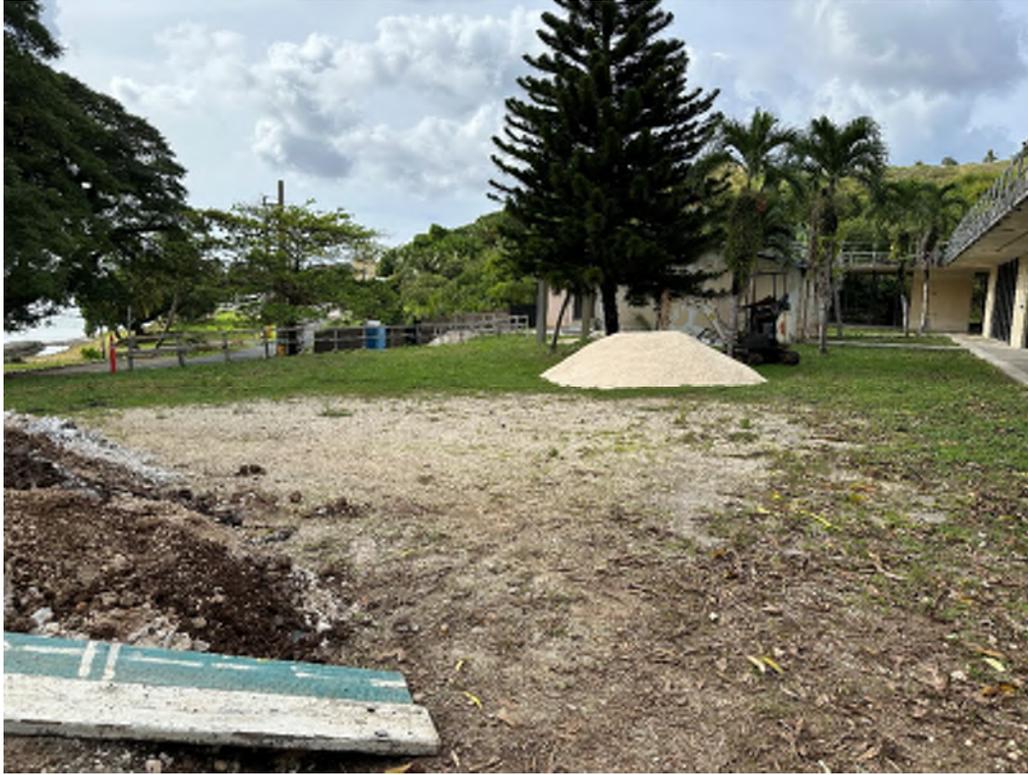
B8.4 Site upkeeping – Front side @ upper level

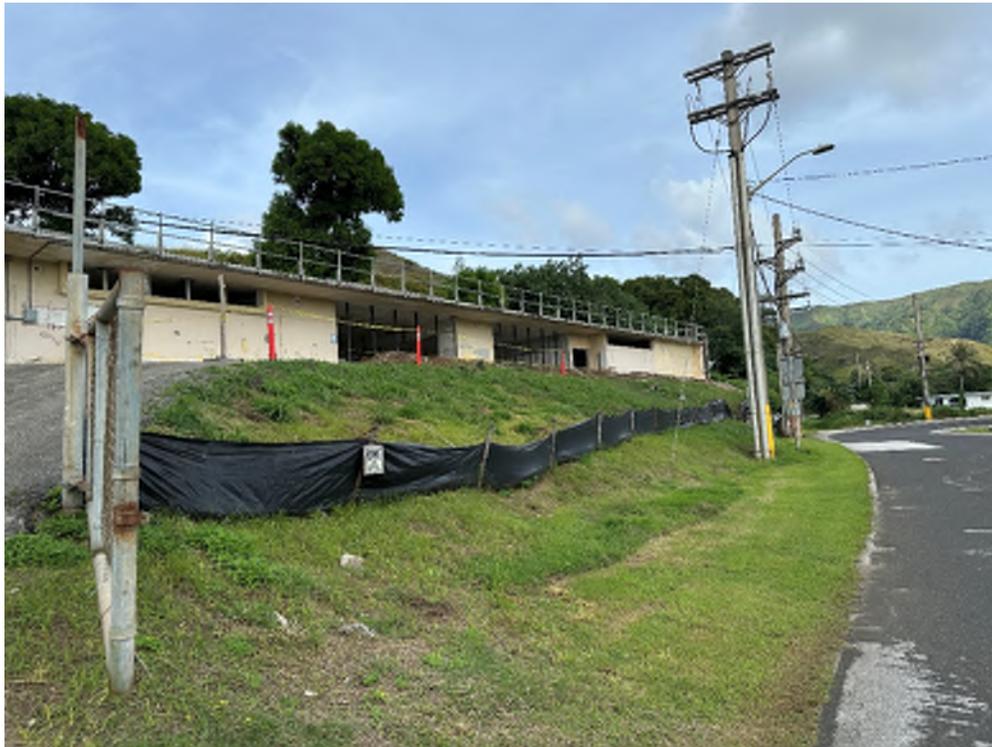
B8.5 Site upkeeping – Front side @ lower level

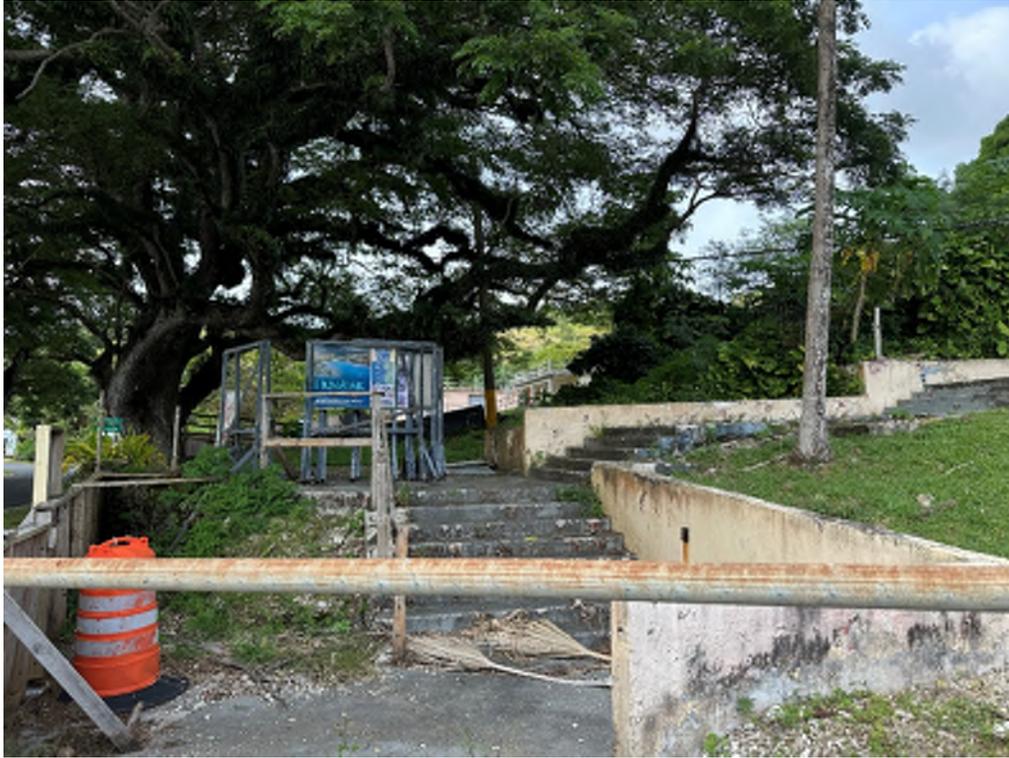
B8.6 Site upkeep – Front side @ walkway

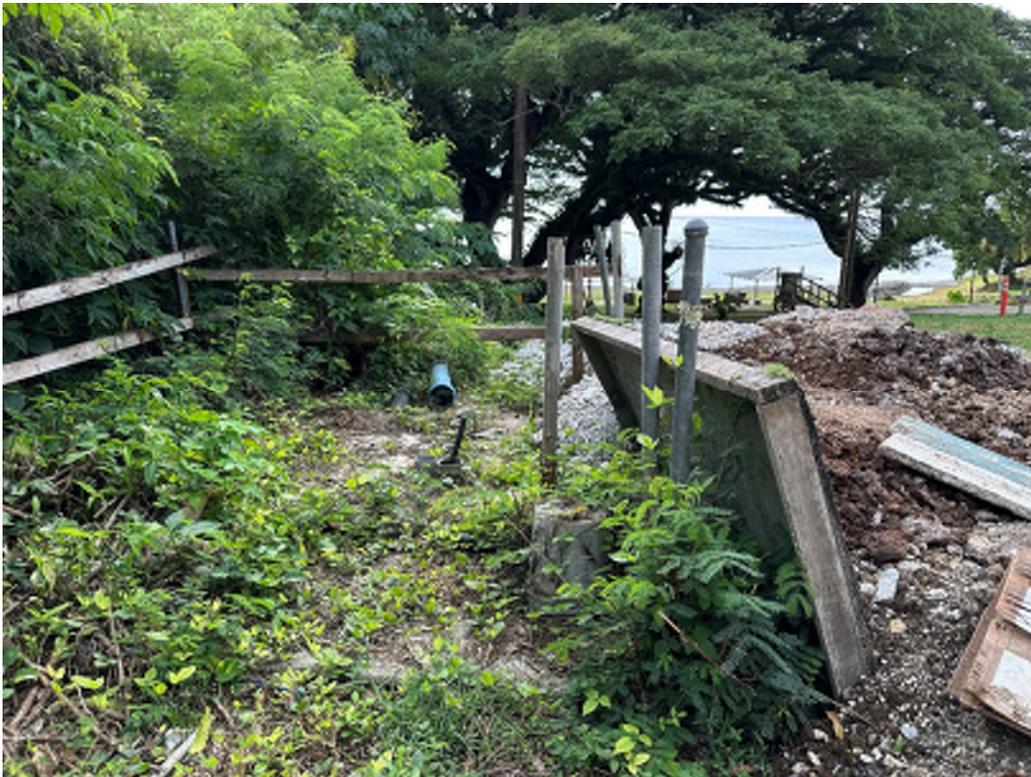
B9.1 Existing transformer removed. Stub-outs need to be secured.

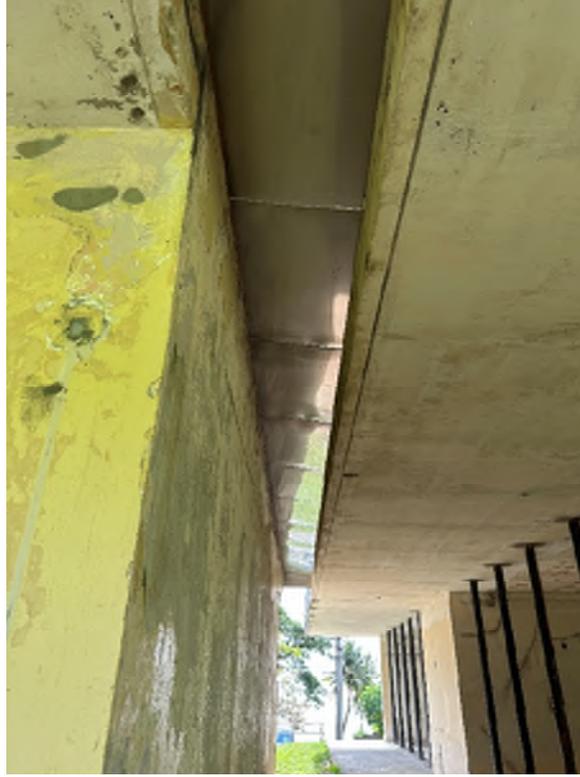
B10.1 Stainless steel flashing between Classroom #5 & #6.

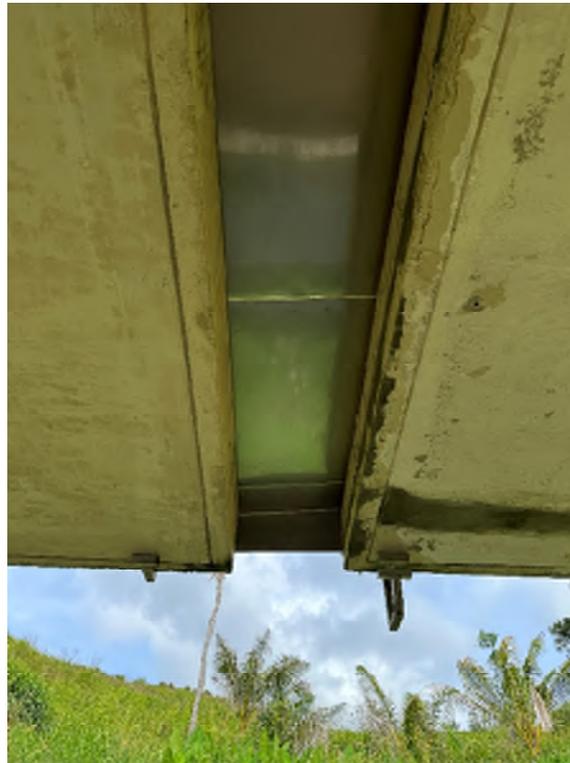
B10.2 Stainless steel flashing between Classroom #5 & #6.
